**CARBON FIBER INSTALLATION AT  
INTERMOUNTAIN POWER SERVICE  
CORPORATION  
UNIT 1 - MARCH 1988  
84", 114" & 120" Diameter PCCP  
Pipe Sections**

**CARBON FIBER INSTALLATION REPORT**

**COOLING WATER SYSTEM – UNIT 1**

**KPFF CONSULTING ENGINEERS, INC.**

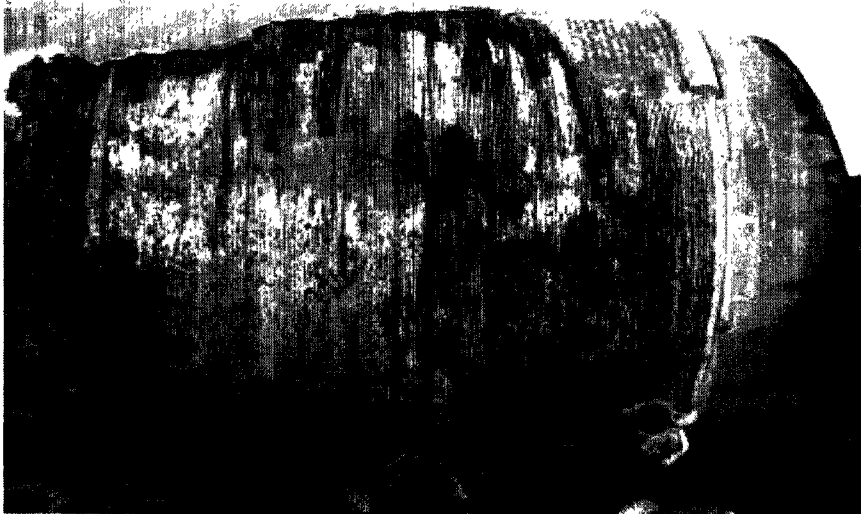
**Photo 14**

84 in. diameter Pipe #476.  
Note longitudinal crack in  
concrete core.

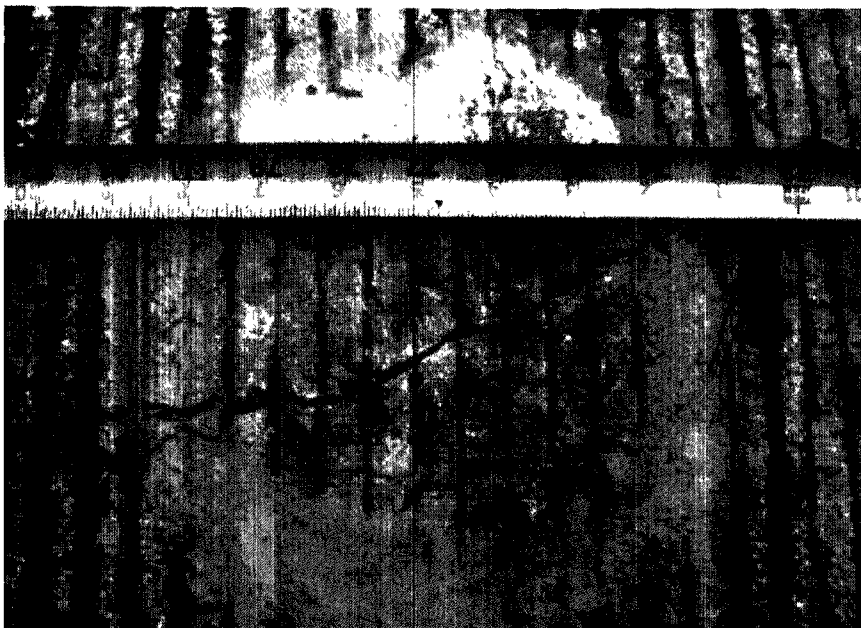
**Photo 15**

84 in. diameter Pipe #476.  
Up to about 1/8 in. wide  
longitudinal crack in the core.

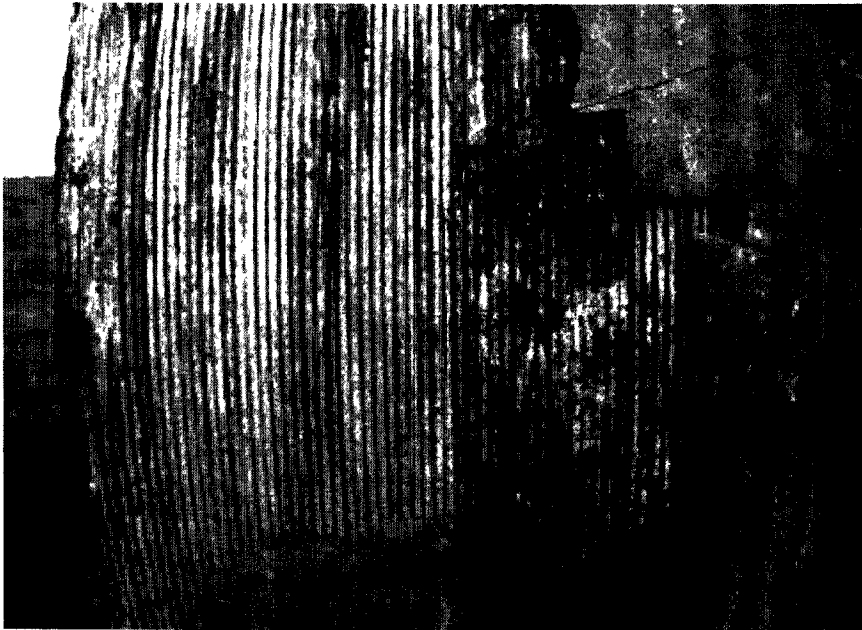
**Photo 16**

84 in. diameter Pipe #476.  
Spalled coating near the  
other end of the pipe.

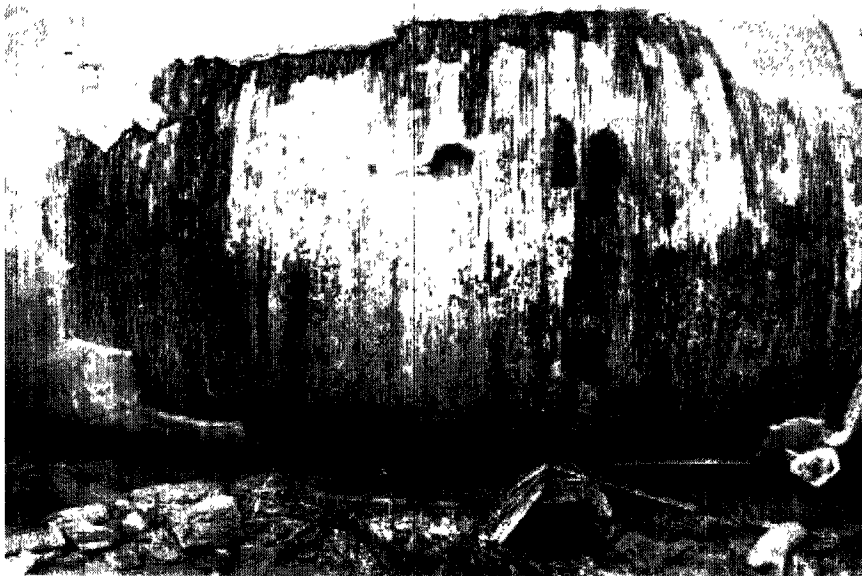
**Photo 17**

84 in. diameter Pipe #476.  
Window opened in core to  
expose the steel cylinder.
